# Manhole Inspection Summary

Manhole # S53AA\_005MH

Insp Date: **7/17/08 11:19 AM**

**Location** Address: **534 n robinson st**

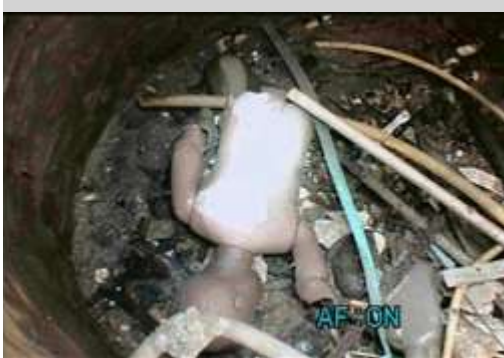
Defect 3

Condition: ☐ Sound ☐ Cracked ☐ Root Intrusion ☐ Deteriorated ☐ Leaks ☒ **Debris**

bench and channel debris

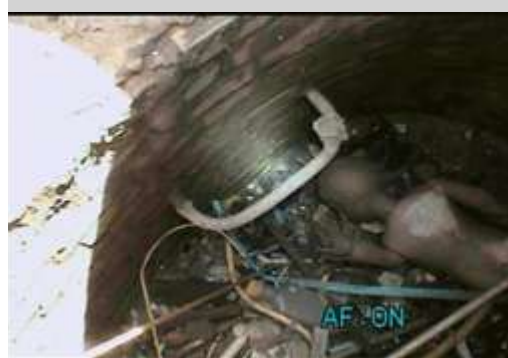
Defect 2

**Steps** Count: **1** Missing: **0** ☒ **Corroded**

corroded step

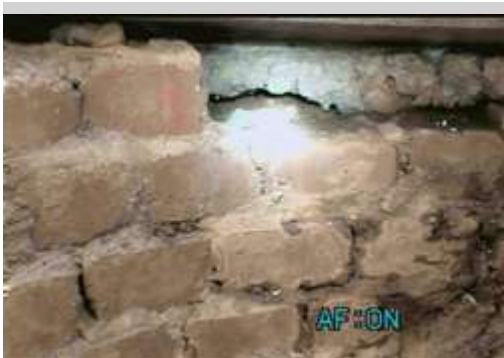
Defect 1

Condition: ☐ Sound ☒ **Cracked** ☐ Root Intrusion ☒ **Loose Brick** ☐ Deteriorated

corbel loose bricks, cracked, frame adj

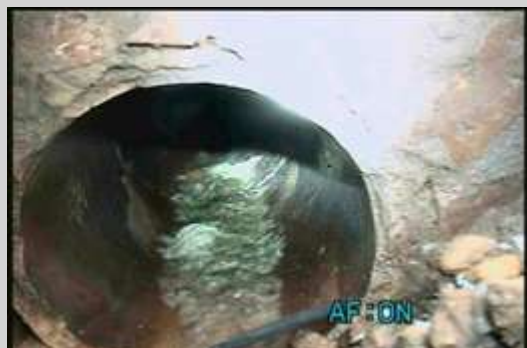
12 O'Clock Outflow

8 in. Circular Gravity Sewer  
Pipe Out @ 12 O'Clock

Deposits: ☐ None ☐ Mud ☐ Sludge ☒ **Debris** ☐ Grease

Silt Depth: 1 (in.) Deposits Extent: **Light**
